Important warranty information concerning astronomical devices

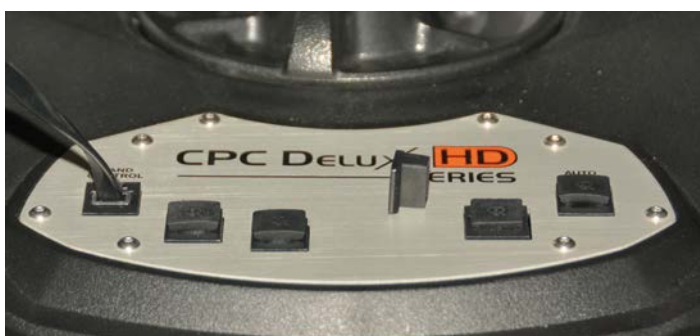
Protective caps prevent that moisture can get in unoccupied sockets, or cables are connected incorrectly and cause short-circuit

4. To protect against moisture or wrong wiring, we recommend to seal unoccupied jacks with protective caps so that dust and moisture cannot attach. For RJ45 jacks (PC connection) and RJ11 jacks (e.g., auto-guider jacks and Celestron manual controllers) we offer a set with protective caps (5x RJ11, 2x RJ45) under the order number #889002. These caps also minimise the risk of connecting accessories to the wrong port in the dark and to cause short-circuits.

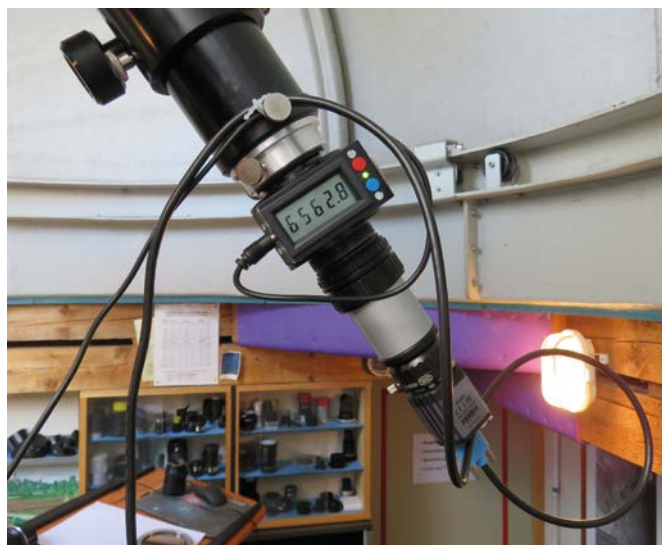
Cable Lock to H-alpha filters: looped, supplied laste steady USB 3.0 cable and power supply, attached to the focuser locking screw.

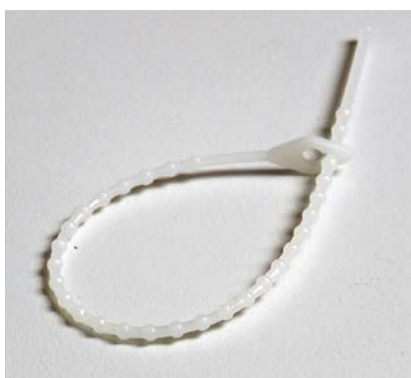
Figure 01: Re-open cable tie (knot ribbon). Figure 02 and 03: Cable loop directly to the USB 3.0 connector of SkyRis camera with tape knot to secure

Insert cable plugs into the lead in loops and secure the loop with a cable tie (Fig. 02 and 03 below). To prevent by bending the cable directly at the plug cable breaks and at the now so filigree connectors such as USB 3.0 on video modules or RJ 11 connectors for car or Selfguiding ports damage to the connectors. In „bulky, hard“ cables (cold temperatures, see Fig. On the right), it is often sufficient, the cable through a loop, for example, supply via a clamping screw or driving the focuser the corresponding port on the mount or the camera.

Work portable, use cable ties which can be opened again (Fig. 01). They are found on the Internet – for example, Conrad Electronics – under the search term „Node Chains“, see also here:

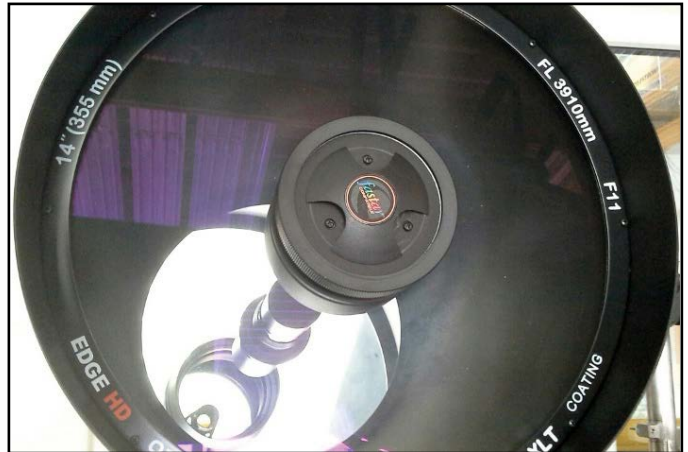
C14 EdgeHD with fogged Schmidt plate (in the right third, diagonal)

Occasionally customers complain especially Schmidt Cassegrain optics, because the Schmidt plate and / or the primary mirror inside „fogged“, and this fog does not disappear. Except for a few cases, these are the residues of condensed humidity, which has passed through unfavorable weather conditions and incorrect handling of the optics in the tube.

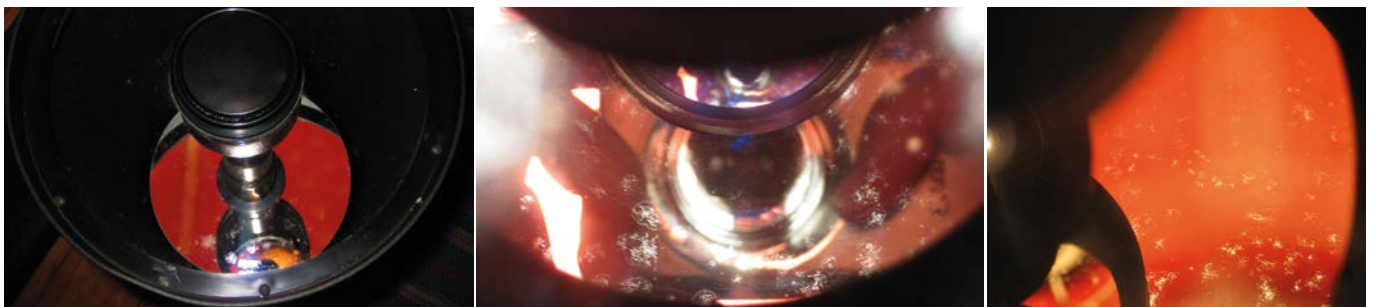
These images show the view into a Schmidt-Cassegrain, which was stored at moist-warm climate near the ocean for some years. Even the closed tube of a SC was no protection against fungus under this conditions.
